(NASA-CR-170883) RESULTS OF TESTS ON A
SPECIMEN OF THE SRB AFT SKIRT HEAT SHIELD
CURTAIN IN THE MSFC LRLF (Lockheed Missiles
and Space Co.) 59 p HC A04/MP A01 CSCL 21H

RESULTS OF TESTS ON A SPECIMEN
OF THE SRB AFT SKIRT
HEAT SHIELD CURTAIN
IN THE MSFC LRLF

June 1980

Contract NAS8-32982

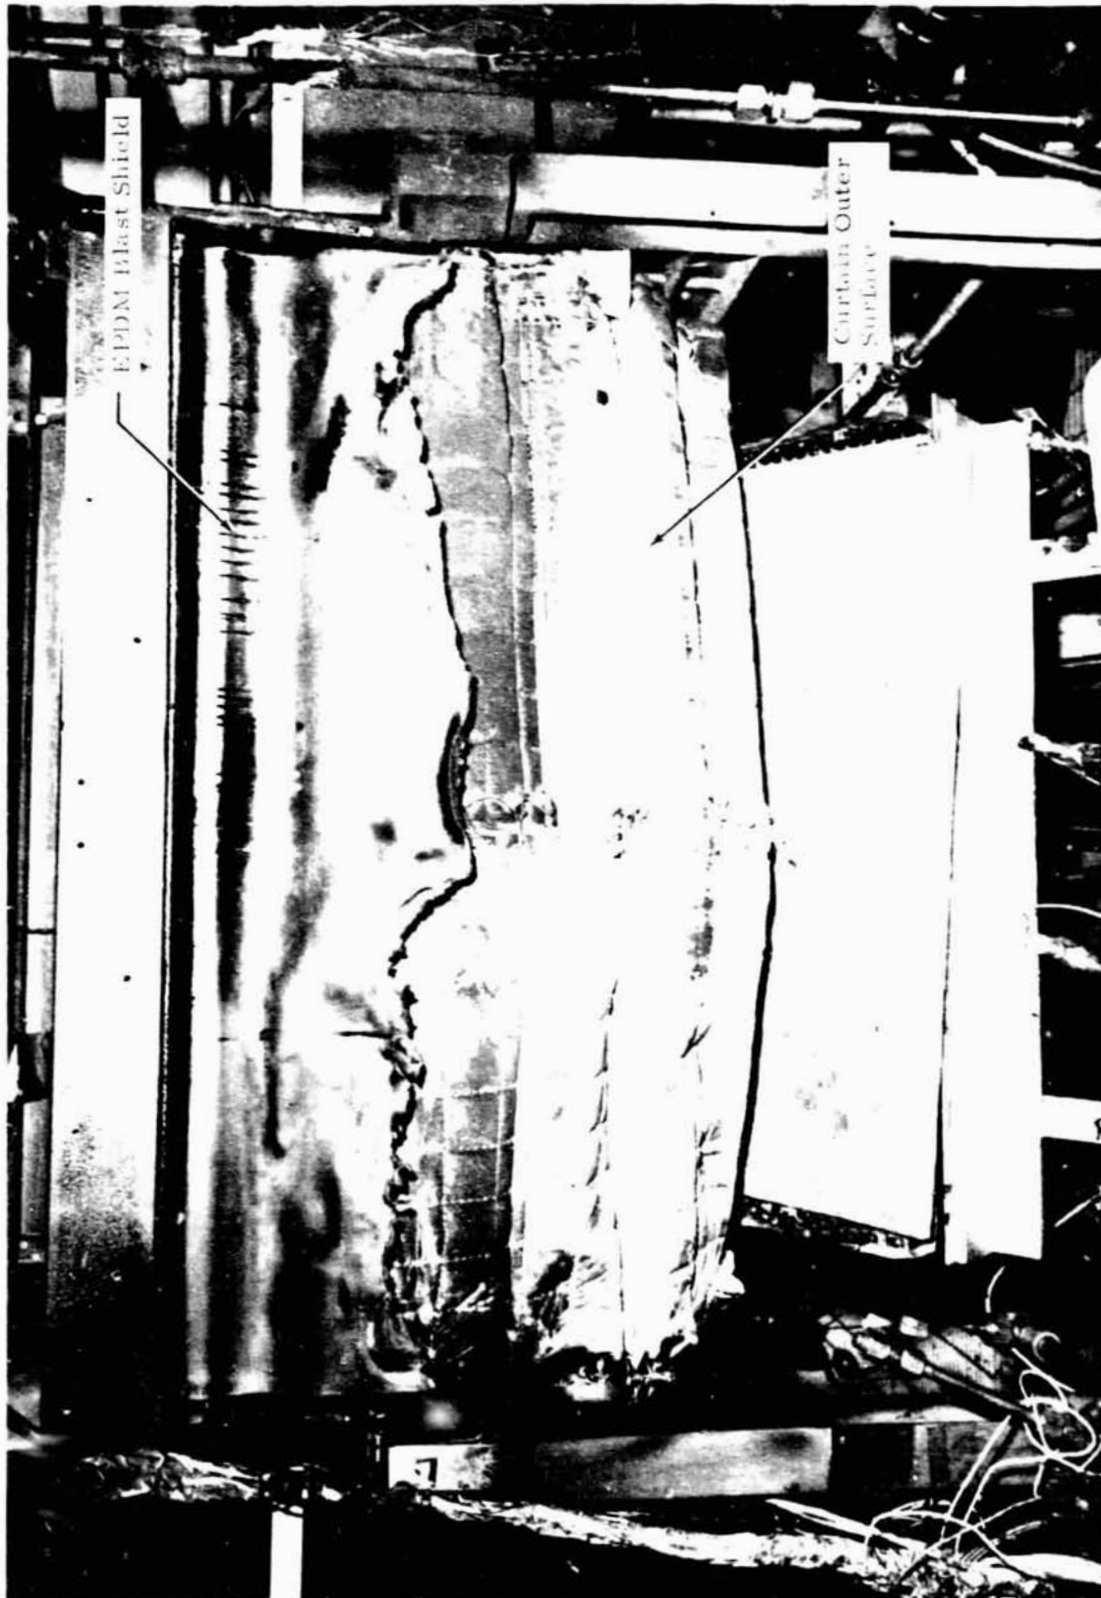
Post-test inspection showed the exterior and interior of the curtain to be in remarkably good condition. Figures 26 through 37 show the post-test photos of the curtain after disassembly of the test setup and curtain itself. Some embrittlement of the inner layer of G 1582 Fiberglas on the outer curtain was observed in the right overlap joint area near TC 30. Since TC 30 was only 140 F at the end of ascent, this embrittlement was attributed to post-test burning of the EPDM blast shield. However, it is planned that post-test material samples will be cut out of the curtain at various critical areas of the curtain where the temperature reached a value near the allowable value.

Fig. 26 - Post-Test Photo of Curtain Looking Upstream from the Nozzle End (EPDM Continued to Burn for a Considerable Period After Test Termination)

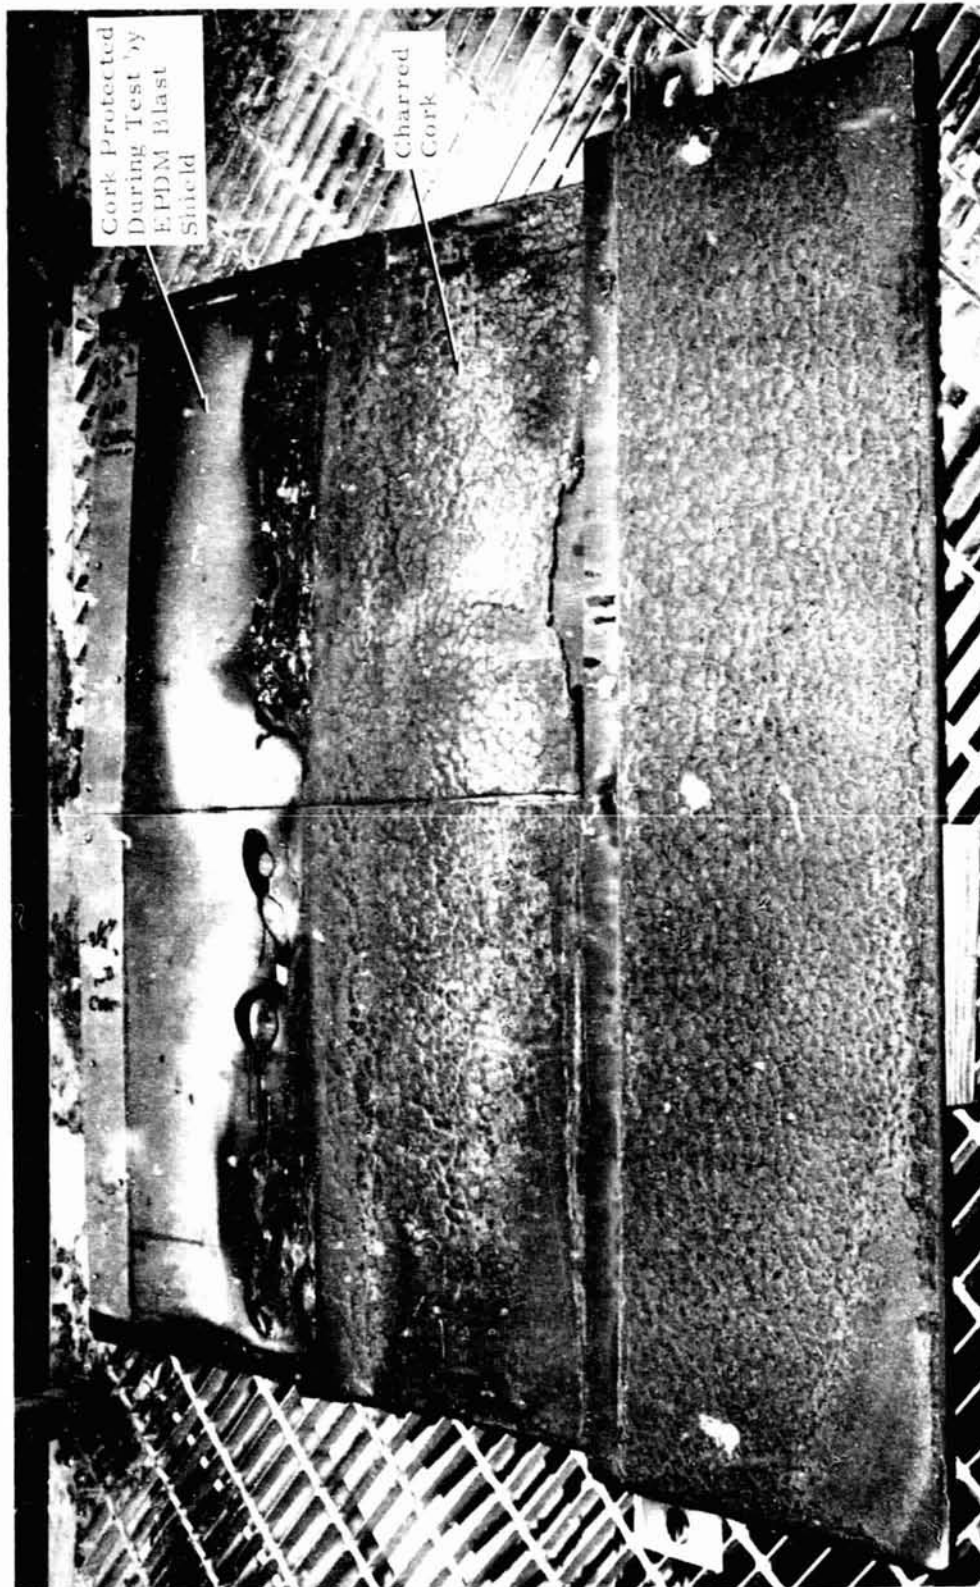
Fig. 38 - Post-Test Photo of Nozzle Simulator Plate

Figures 38 and 39 show the nozzle simulator plate and aft ring attachment area with cork burned away.
